Release Notes

SV9100 CP10 A10.60.55

Product	-	Univerge SV9100 CP10
Version	-	Release A10.60.55
Date	-	08-Sep-2020
Document Reference	-	FCO 2020.071
Category	-	Maintenance
Issued by	-	NEC Enterprise Solutions EMEA

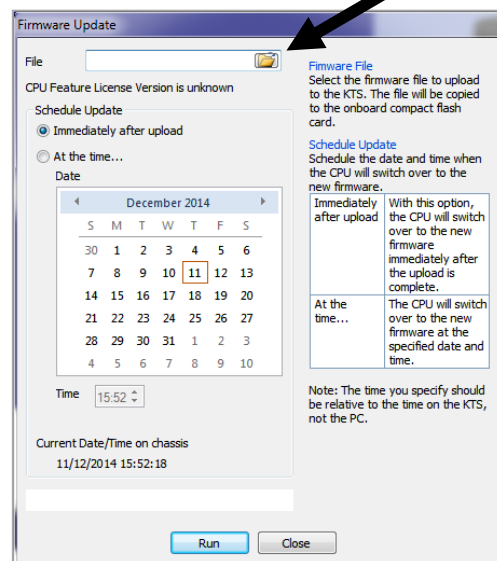
In the File box, select the mdu file you created for the upgrade, then select when the upgrade should occur (immediately or the date specified). At this point the system will perform its normal upgrade cycle and reboot.
