Release Notes

SV9100 CP20 R10.60.55

Product	-	Univerge SV9100
Version	-	Release 10.60.55
Date	-	21-Sep-2020
Document Reference	-	FCO 2020.077
Category	-	New Features
Issued by	-	NEC Enterprise Solutions EMEA

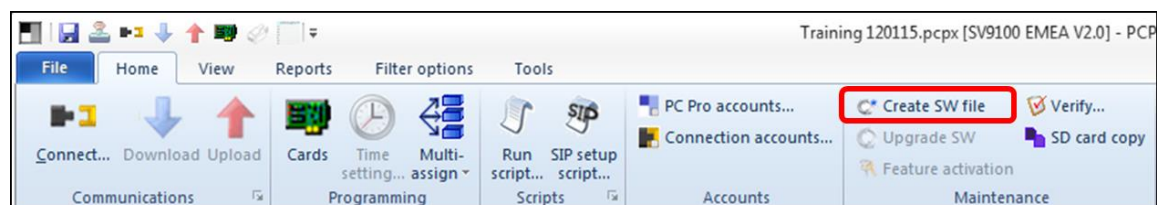
First create a remote upgrade file from the same software you would add to the USB stick.

From the ribbon bar, select Create SW file:

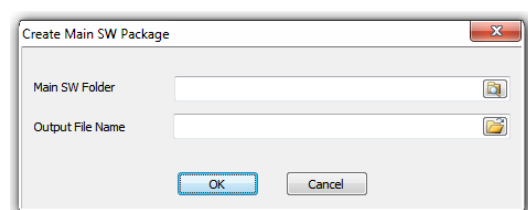
This will pop a window:
