Release Notes

SV9100 CP20 R14.11.51

Product	-	Univerge SV9100
Version	-	Release 14.11.51
Date	-	25-Nov-2025
Document Reference	-	FCO 2025.021
Category	-	Minor release
Issued by	-	NEC Enterprise Solutions EMEA

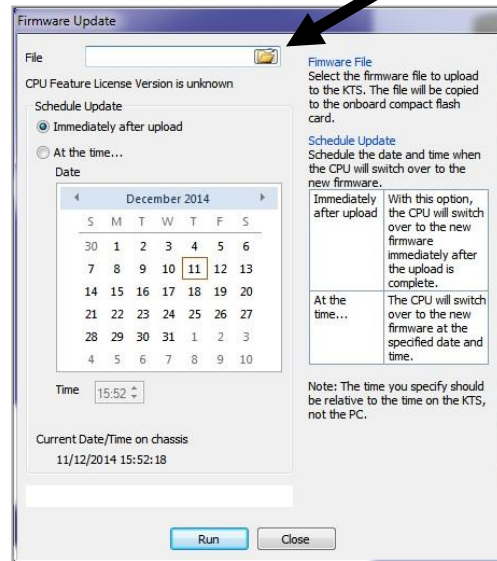
Connect to the system via PCPro in the normal manner, and from the ribbon bar select Upgrade SW

In the File box, select the mdu file you created for the upgrade, then select when the upgrade should occur (immediately or the date specified). At this point the system will perform its normal upgrade cycle and reboot.
